NASA
Technical Memorandum 106553

An Enhancement to the NA4 Gear Vibration Diagnostic Parameter

Harry J. Decker and Robert F. Handschuh
Vehicle Propulsion Directorate
U.S. Army Research Laboratory
Lewis Research Center
Cleveland, Ohio

Prepared for the
18th Annual Meeting
sponsored by the Vibration Institute
Hershey, Pennsylvania, June 20-23, 1994

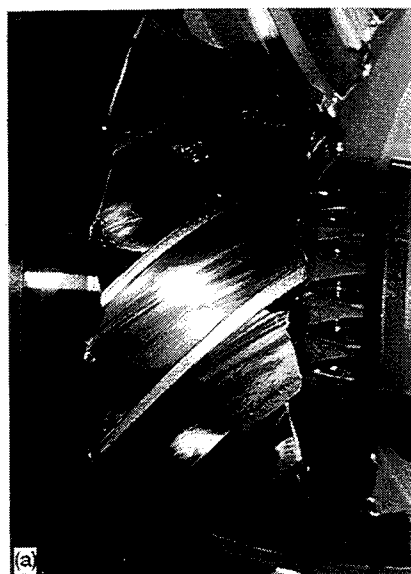
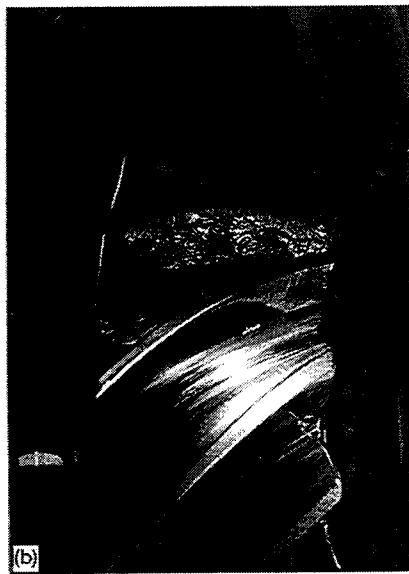
Figure 4.—Damage to Spiral Bevel pinion. (a) At 5.05 hr. (b) At 12.03 hr. (c) At end of run.

Data from one spiral bevel test were obtained. Pictures of tooth damage on the pinion at various stages in the test are illustrated in figures 4a, 4b, and 4c. The rig was shut down a total of eight times to observe and document the damage as it progressed during the run. Only the results of three of these shutdowns will be discussed. At the first shutdown, at about five and one half hours into the test, a small pit was observed on one of the teeth on the test pinion as illustrated in figure 4a. At approximately twelve hours into the run, pitting started to appear on adjacent teeth, as seen in figure 4b. The pitting on the adjacent teeth continued to grow until it covered a majority of the face of three adjacent teeth on the pinion, and part of the face of another adjacent tooth. The run was stopped when one of the three heavily pitted pinion teeth was found to have fractured, losing one-third of the tooth, as illustrated in figure 4c. The fracture occurred between 16.16 and 17.79 hours into the test.
